April 6, 2010
Project 06463-1

**Re: Site Visit Observations and Preliminary Recommendations
Fosters Pond Dam, NID # MA00153
Andover, Massachusetts**

This letter report describes our site visit observations of Fosters Pond Dam located in Andover, Massachusetts made on April 2, 2010. We also provide preliminary recommendations based on these observations. The site visit was conducted on May 8, 2008 by R. Lee Wooten, P.E., of GEI Consultants, Inc. of Woburn, Massachusetts.

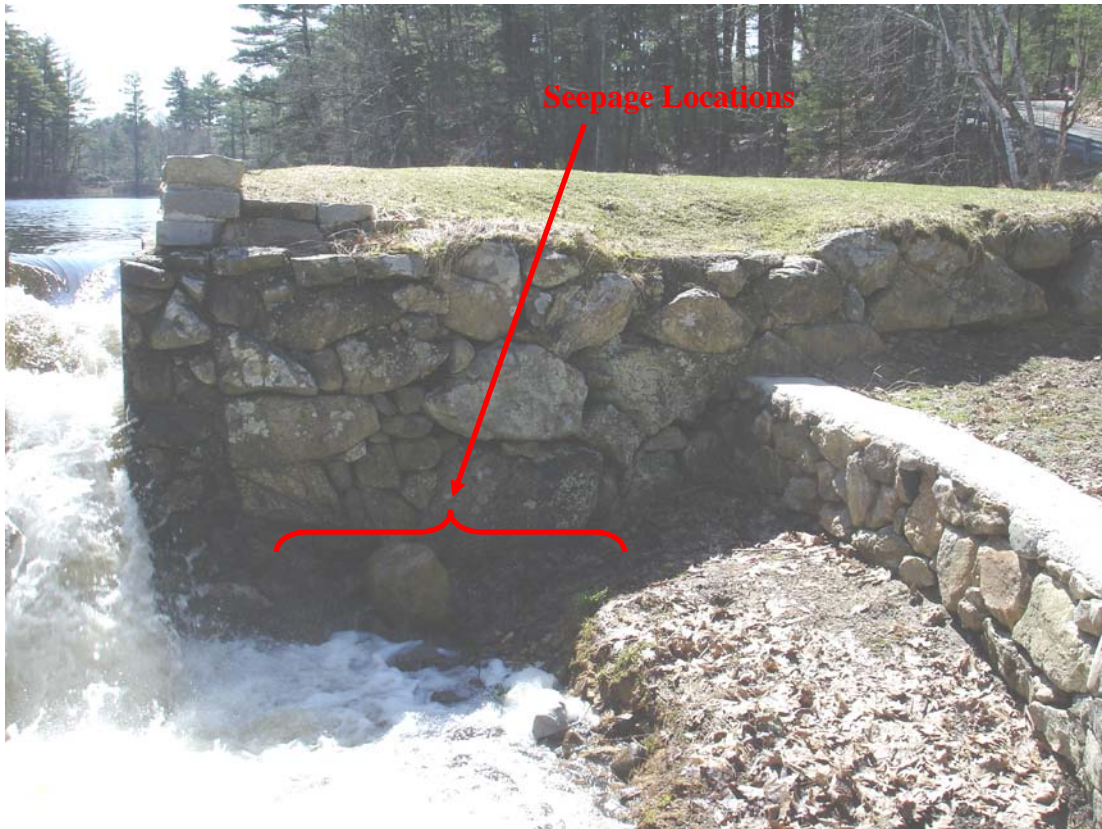
- Seepage was flowing at the base of the downstream unmortared masonry wall below and to the southwest or left (for an observer facing downstream) of the main spillway (see Photos 1 and 2). We had observed flow in this area during our previous site visits. The observed flow rate was several gallons per minute. You noted that this flow rate had increased following each of the recent rain events.

Photo 1 – Seepage locations along left downstream wall from downstream

- Initiate permanent repairs of the dam as soon as practical after the pond reaches the level of the sluiceway sill. Permanent repair should include:
 - A graded filter against the upstream side of the high section of the left downstream unmortared masonry dam. We expect that the graded filter should include:

- A 12-inch-thick (minimum) layer of large crushed stone (e.g., 3-inch) or small cobbles (e.g., 6-inch). The large crushed stone or cobbles must be larger than the voids in the masonry.

- A 12-inches-thick (minimum) layer at least of 1-¼ inch crushed stone (Massachusetts Highway Department [MHD] M2.01.3) over the large crushed stone. The 1-¼ inch crushed stone must be larger than the voids in the large crushed stone layer.

- A 12-inches-thick (minimum) layer of ¼-inch crushed stone (MHD M2.01.6) over the 1-¼ crushed stone layer.
 - A 12-inches-thick (minimum) layer of concrete sand (ASTM C33 fine aggregate) the ¼-inch crushed stone layer.The upstream half of the dam should be made as watertight as possible before starting the excavation to install the graded filter. You may want to consider using large plastic tarps and sand bags to form the upstream water barrier. We expect that dewatering the excavation will require a construction dewatering pump.

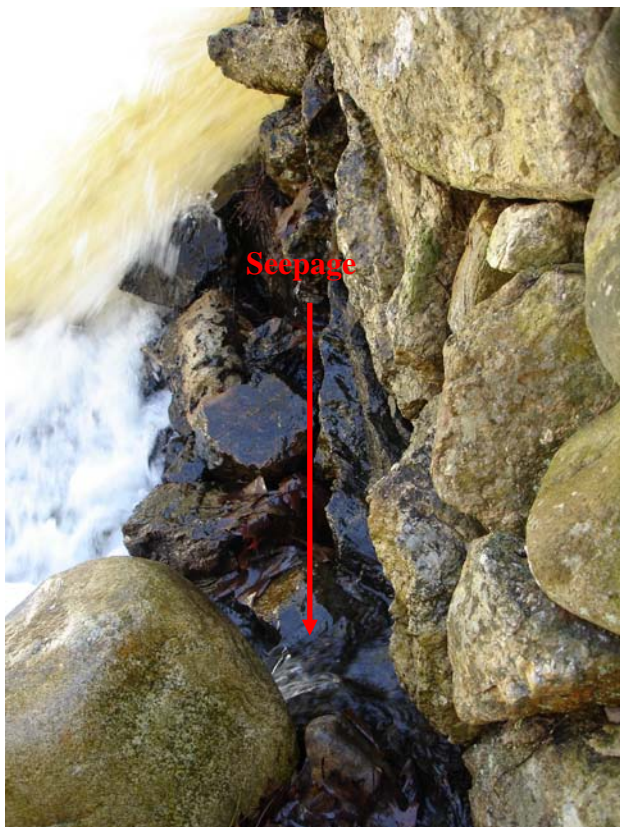
Photo 2 – Seepage, looking down at wall base

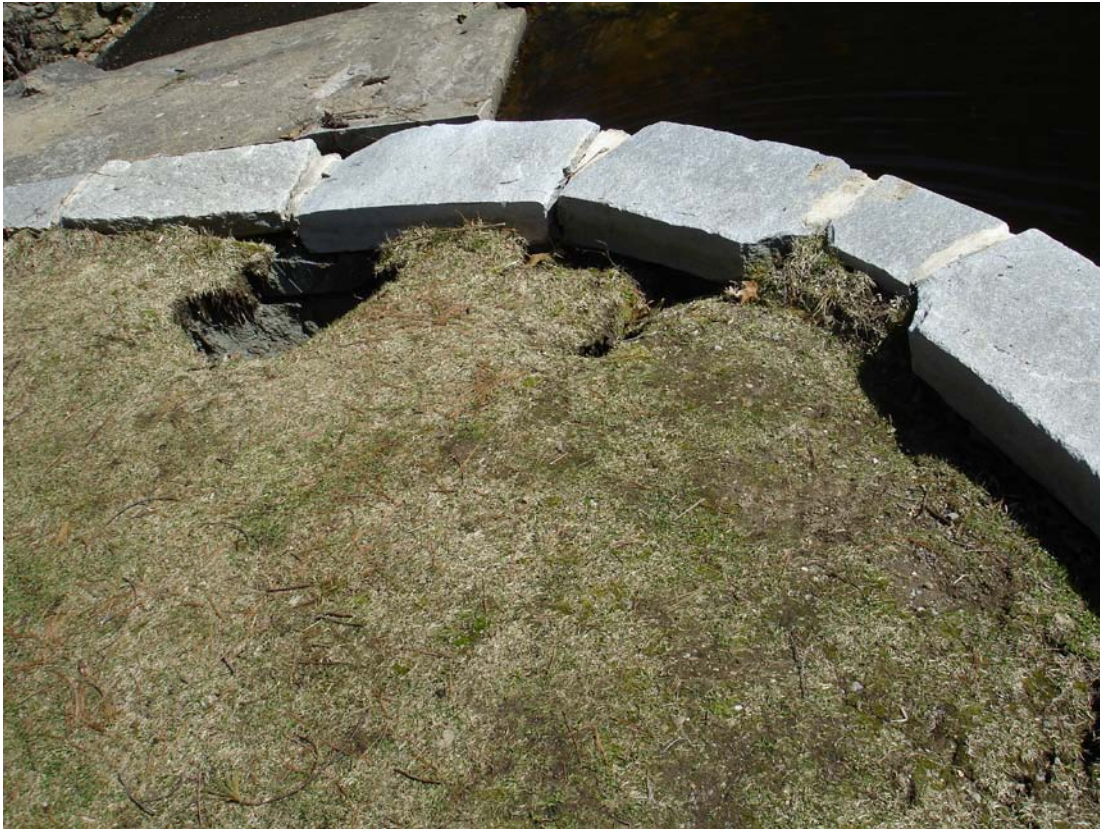
- Several sink holes have formed on the crest of the left / southwest embankment of the dam immediately adjacent to the mortared masonry wingwall (see Photos 3 & 4). The deepest sinkhole was at least 3.5 feet deep. The sinkholes extended through the upper embankment soil which appeared to consist of sandy silt / silty sand. You noted that these sinkholes appeared following the rain events of the past week.
- The mortared masonry blocks of the upstream part of the left spillway wingwall have moved out (away from the embankment) and have gaps of up to about ¾ inch at joints between the masonry blocks (see Photo 5). The movement may be the result of frost action pushing on the wingwall.

We did not observe similar conditions on the right embankment or other conditions of concern. However, these observed conditions indicated that internal erosion has taken place in the embankment. We expect that the rains and higher pond levels have caused flow through the wingwall and upstream parts of the embankment which have eroded soil material through the open masonry of the downstream wall. This process of internal erosion is likely to continue, especially when the pond is high, and may result in a breach of the dam.

Photo 3 – Sinkholes on left embankment looking toward the spillway

- Monitor the embankment on a regular basis, one to two times daily, to look for changed conditions of the sinkholes or formation of a breach. Monitor more frequently during heavy rain or high pond events. Notify local emergency officials to close the portion of Rattlesnake Hill Road below the dam if active erosion likely to lead to a breach is observed. Monitor seepage for changing conditions and new locations downstream of the dam and development of sinkholes within the embankment.

- Place emergency repairs immediately to consist of stuffing two or three 3- to 4-foot square sections of nonwoven geotextile into the sinkholes as deep as they can be pushed and filling the remainder of the sinkholes with concrete sand.

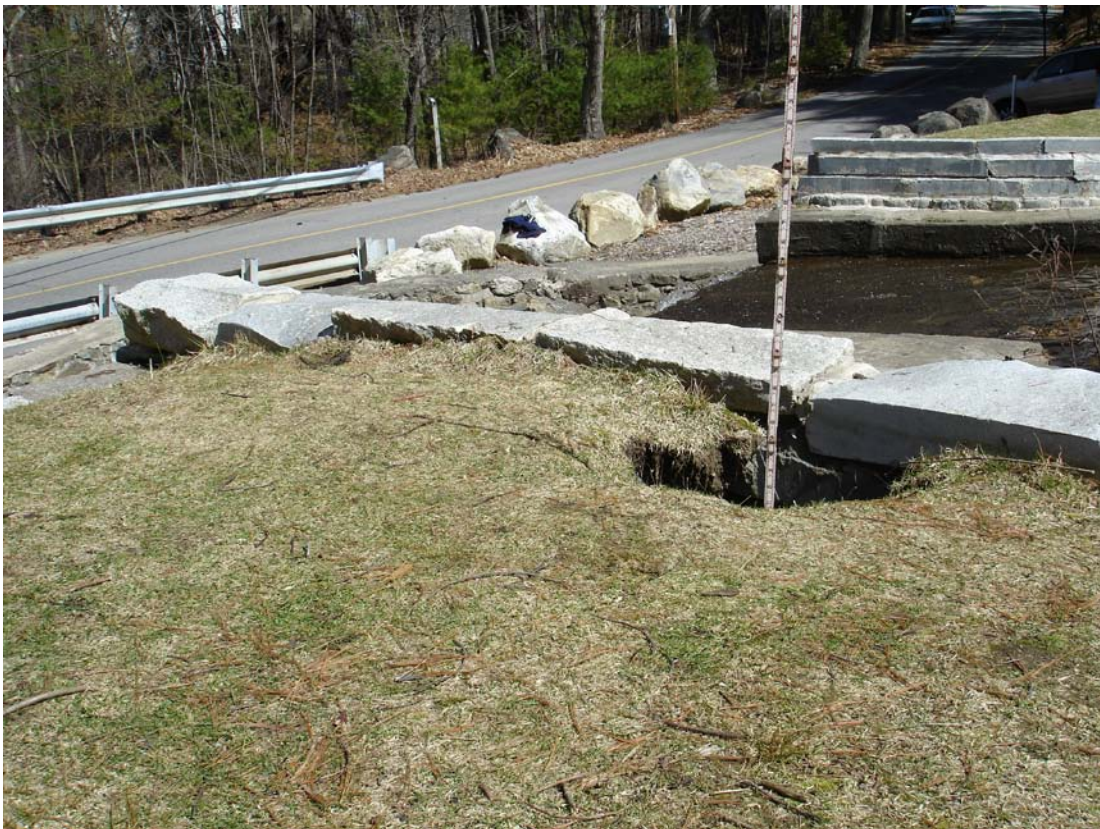
Photo 4 – Sinkhole on left embankment looking toward the spillway

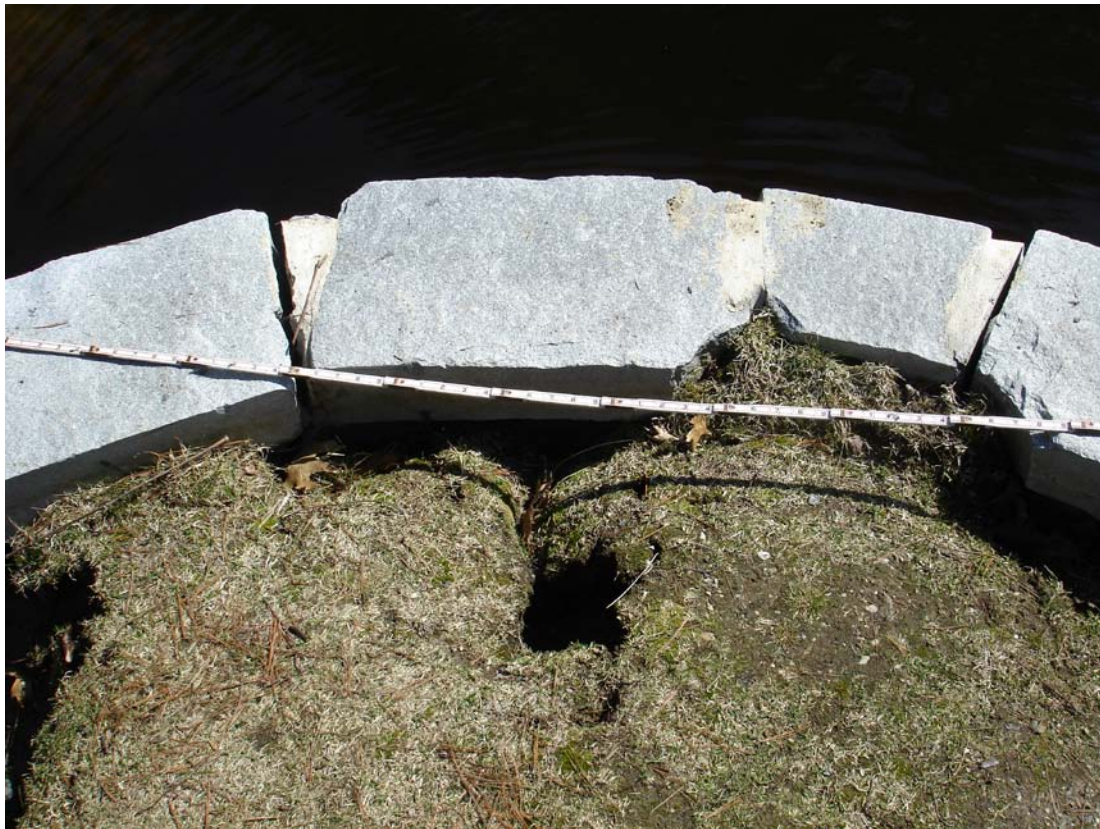
Photo 5 – Left spillway wall, cracked joints, and sinkholes

- Repairs to the upstream half of the left wingwall consisting of a 2-foot or thicker reinforced concrete back wall extending to as deep a depth as practical, but at least 4 feet to get below frost depth. Reinforcing should consist of #4 rebars spaced no greater than 9 inches apart. The reinforcing will reduce the potential for cracking. Concrete should be mixed to provide a strength of about 4000 pounds per square inch and should include air entrainment to reduce the potential for freezing damage. The wingwall repairs may be done before or after installation of the graded filter, but both repairs should not be performed at the same times so that the amount of excavation is minimized. Backfill around the new back wall should consist of soil materials similar to the existing dam materials so that a preferential seepage path is not placed next to the wall. The top of the backfill over the wall should be graded to provide good surface drainage.

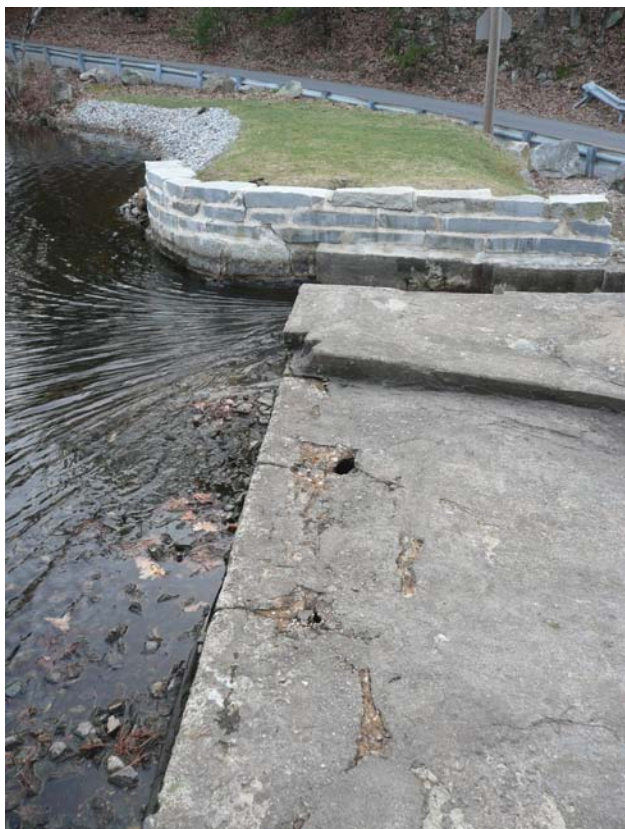
We understand that you visited the site on April 5, 2010 and observed the crest of the concrete spillway after the pond level had dropped below the crest (see Photos 6, 7, and 8). You observed at least two holes in the concrete crest cover opening into voids that extended 1 to 2 feet into the crest structure. The voids appeared to be formed in a cobble, gravel and soil matrix.

Photo 6 – Spillway crest*

- Repairs to the spillway crest structure consisting of pouring a flowable mortar or grout into the cavities that have formed in the crest. The flowable mortar mix product Sika Monotop 611 should be suitable for the repairs of the voids and is available in Boston.

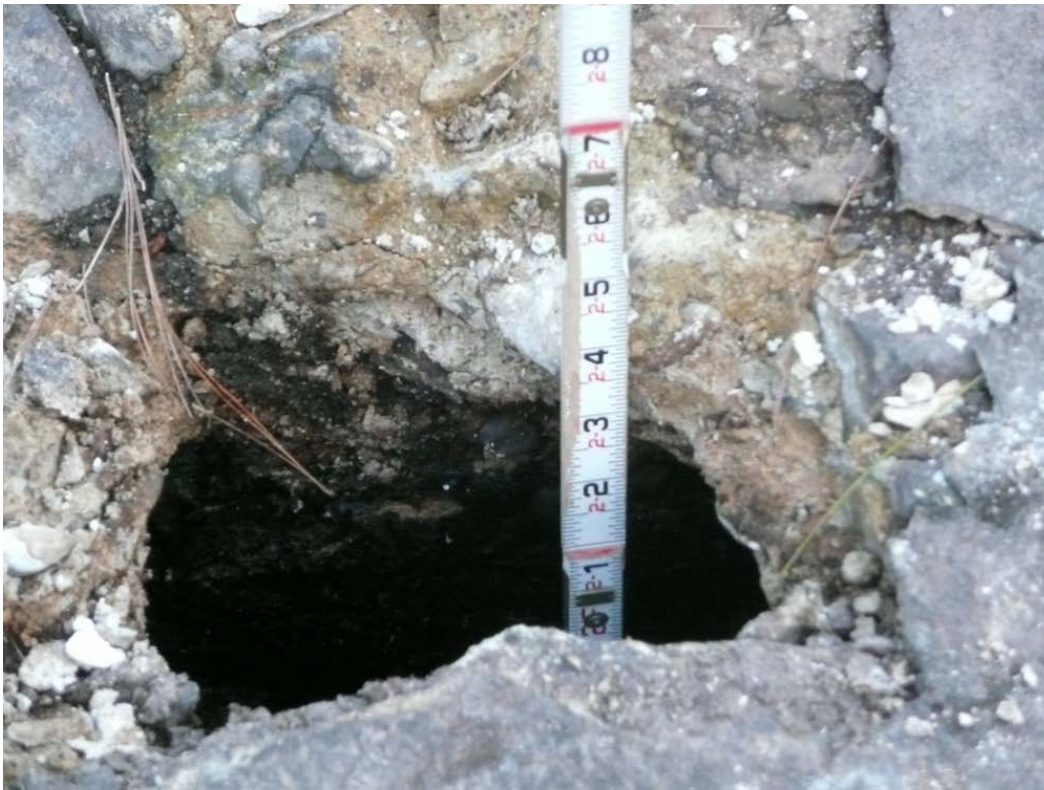
Photo 7 – Spillway crest void*

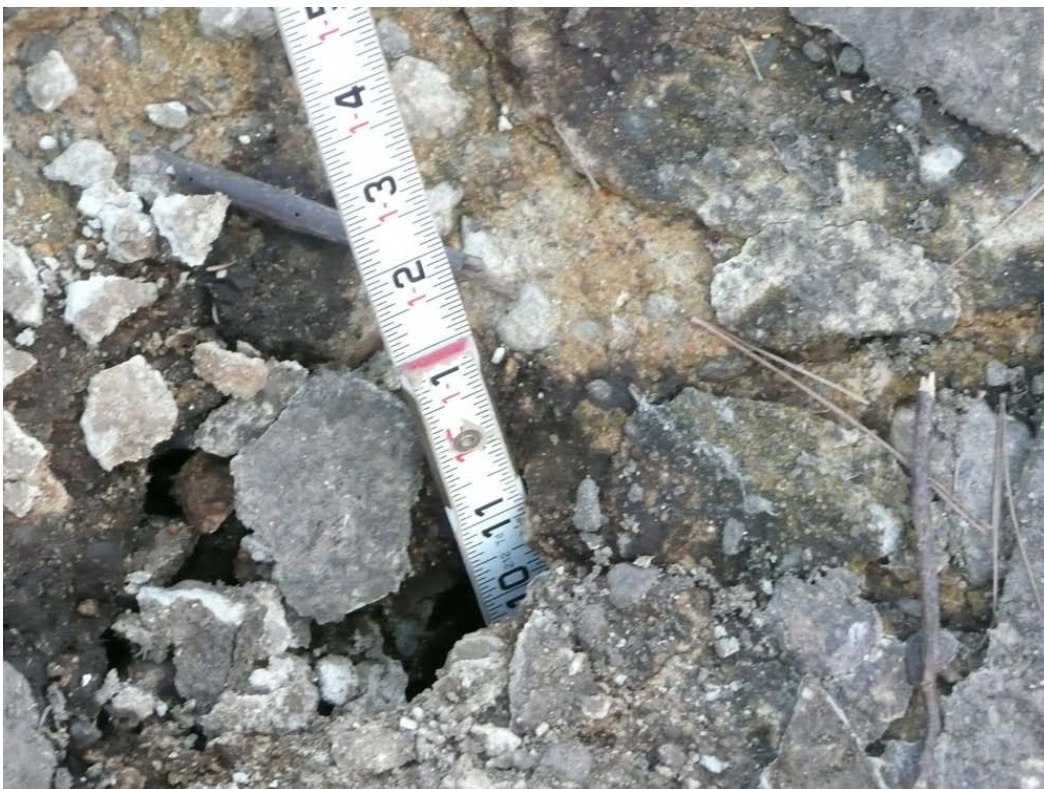
Photo 8 – Spillway crest void*
