2005 PROJECT COMPLETION REPORT

**AQUATIC MANAGEMENT PROGRAM
FOSTER'S POND**

**Aquatic Control Technology, Inc.
11 John Road
Sutton, MA 01590-2509**

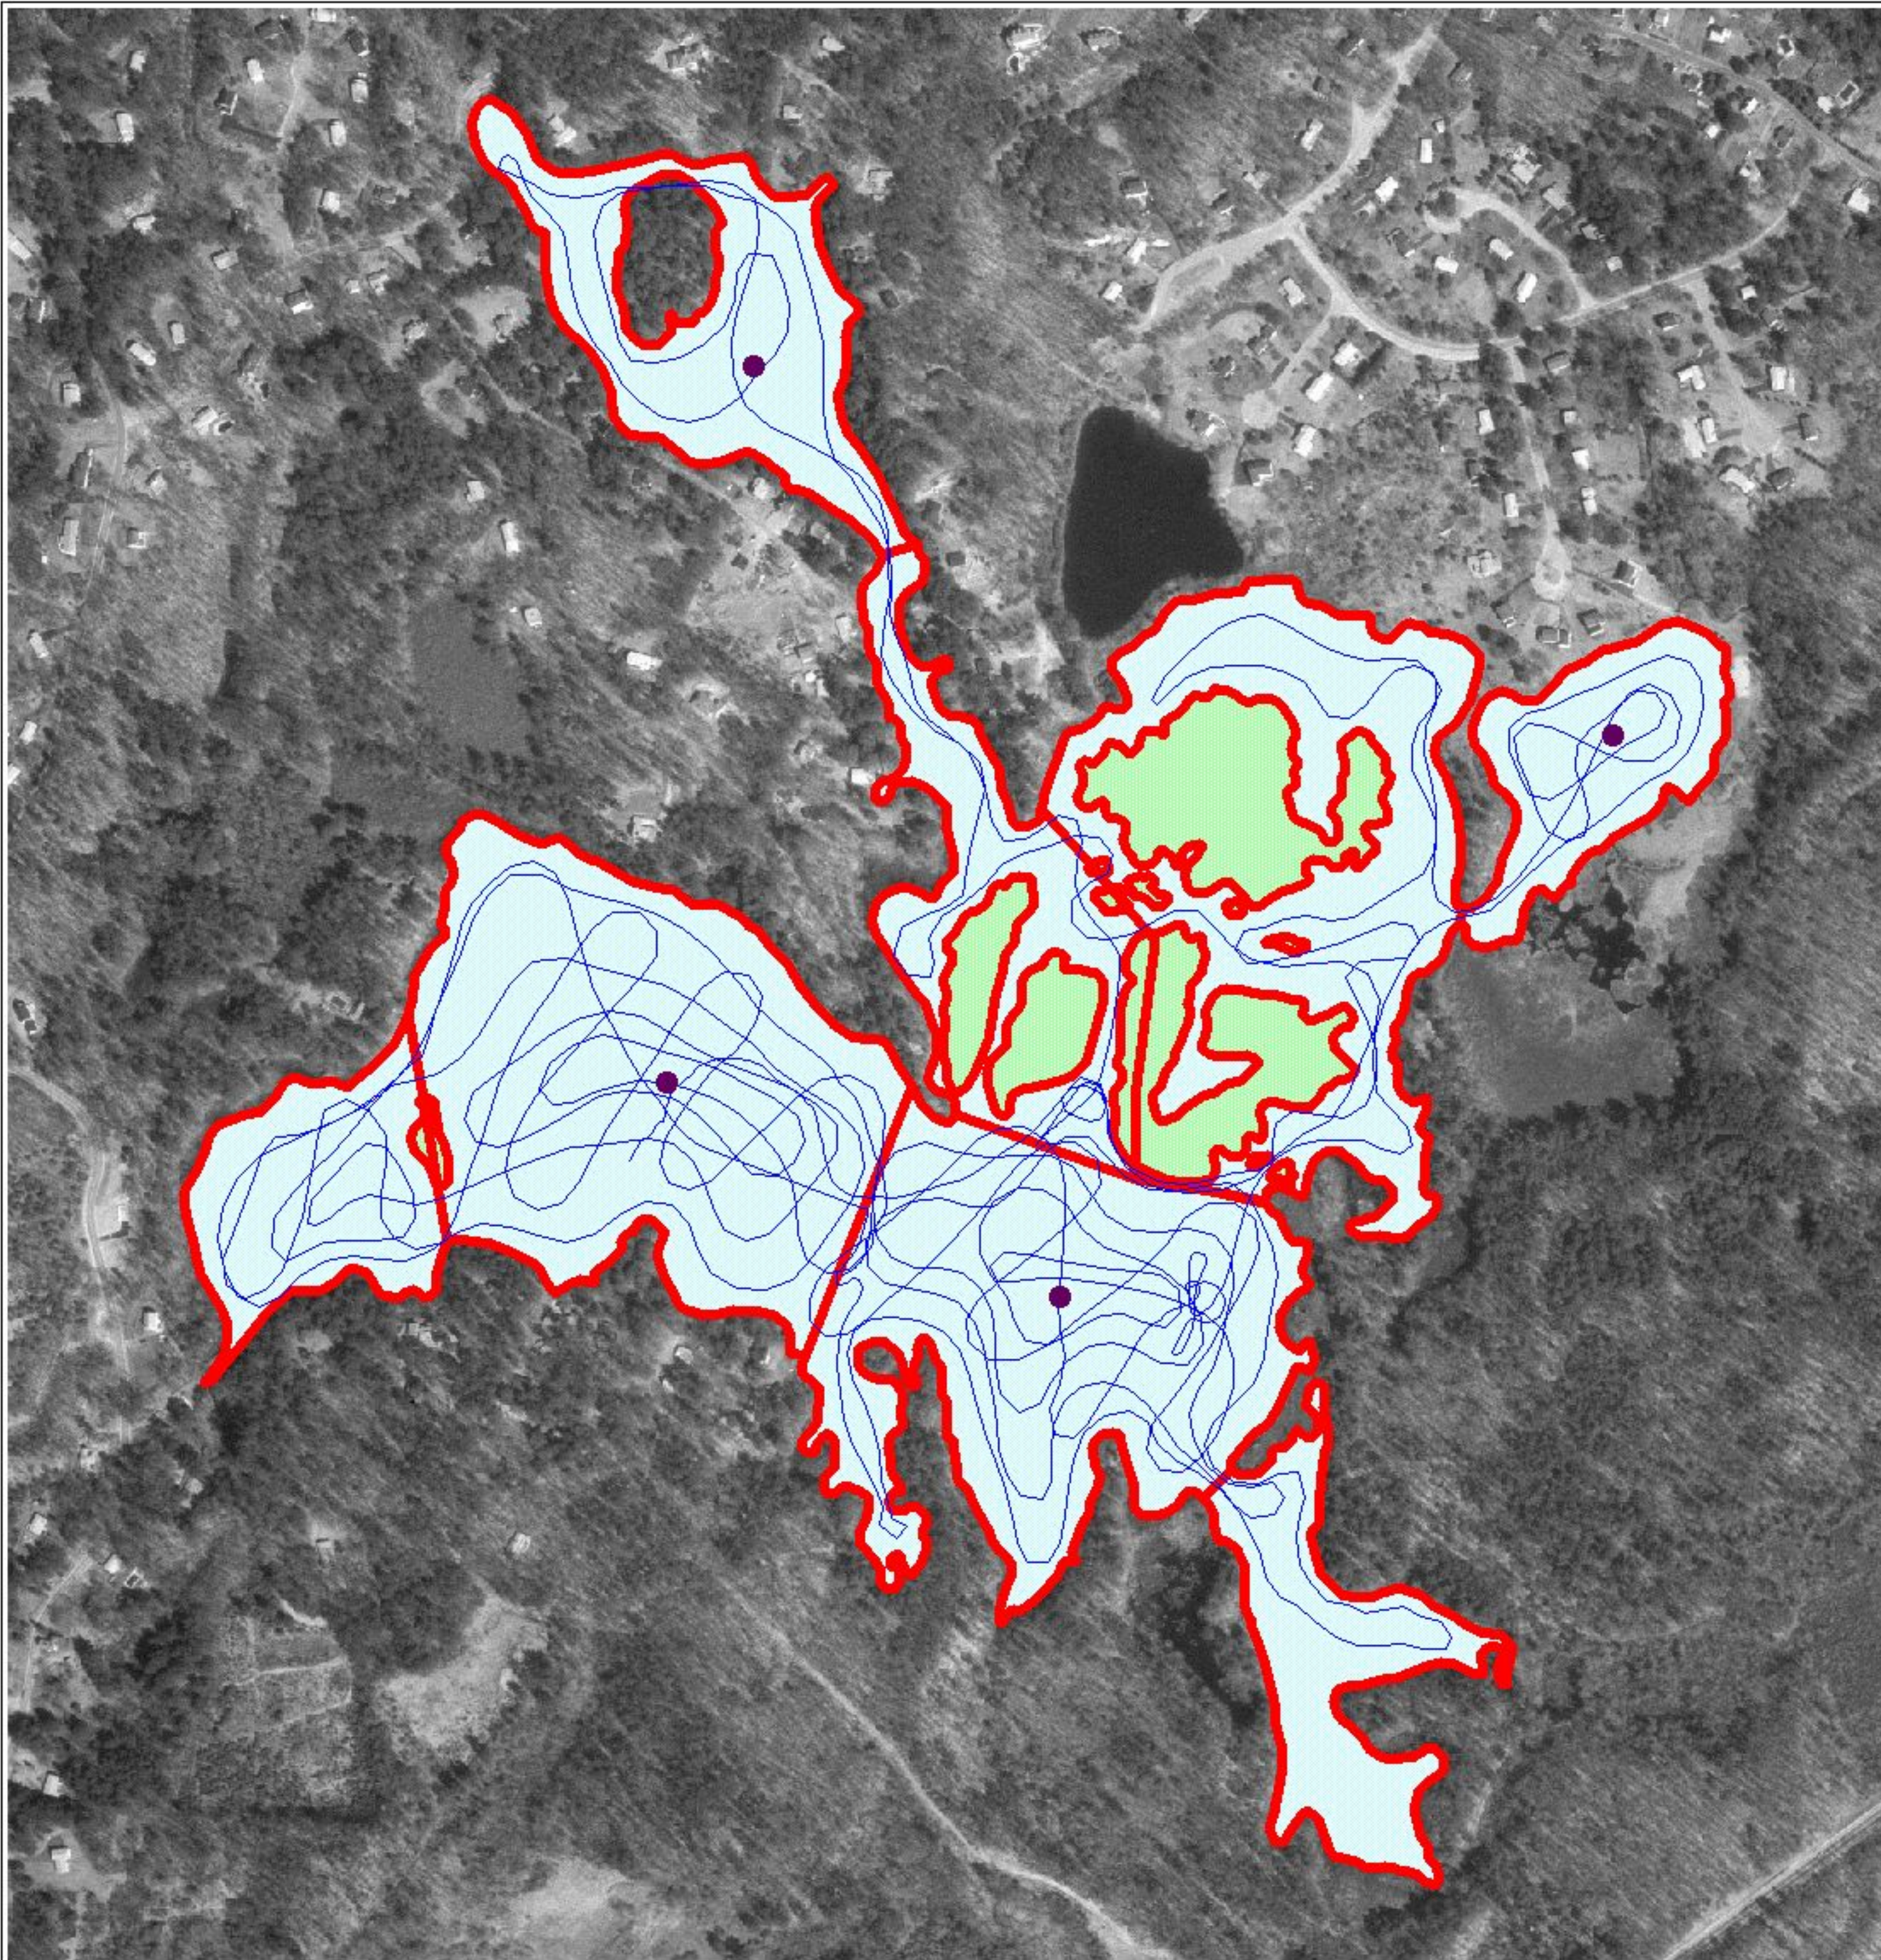
FIGURE 1

**Treatment Basins, FasTEST
Locations & DGPS Treatment Path**

-   FasTEST Sample Locations
-   Treatment basins
-   Floating islands
-   Airboat treatment path (6/6/05)

For descriptive purposes the pond is broken into separate geographic areas throughout the balance of this report. The areas defined below are specifically outlined in Figure 1.

Prior to treatment, we divided the pond into a series of basins as shown in Figure 1. Using the existing bathymetry map for the pond and measurements collected during our pre-treatment inspection, we calculated the water volume and amount of Sonar needed for each basin. The specific amount of Sonar required to achieve the target concentration in each basin was then mixed and applied accordingly.

During all three treatments we utilized a Differential GPS system as a navigational tool. This system has sub-meter accuracy. A map of the pond and the treatment basins was created using ArcView - GIS based software. This map was then downloaded into the GPS unit. This allowed us to follow our position on the screen of the GPS unit and evenly apply the herbicide by making parallel passes that were spaced approximately 100 feet apart (see Figure 1). The system worked flawlessly during all three treatments. As back up, temporary surface buoys were also used to mark the bounds of each basin during each treatment.

Samples were collected on 4 different occasions from four pre-established sampling locations (see Figure 1). Results of the in-pond surface samples are compiled in Table 1. These FasTEST results are also plotted in the chart found in the Appendix.

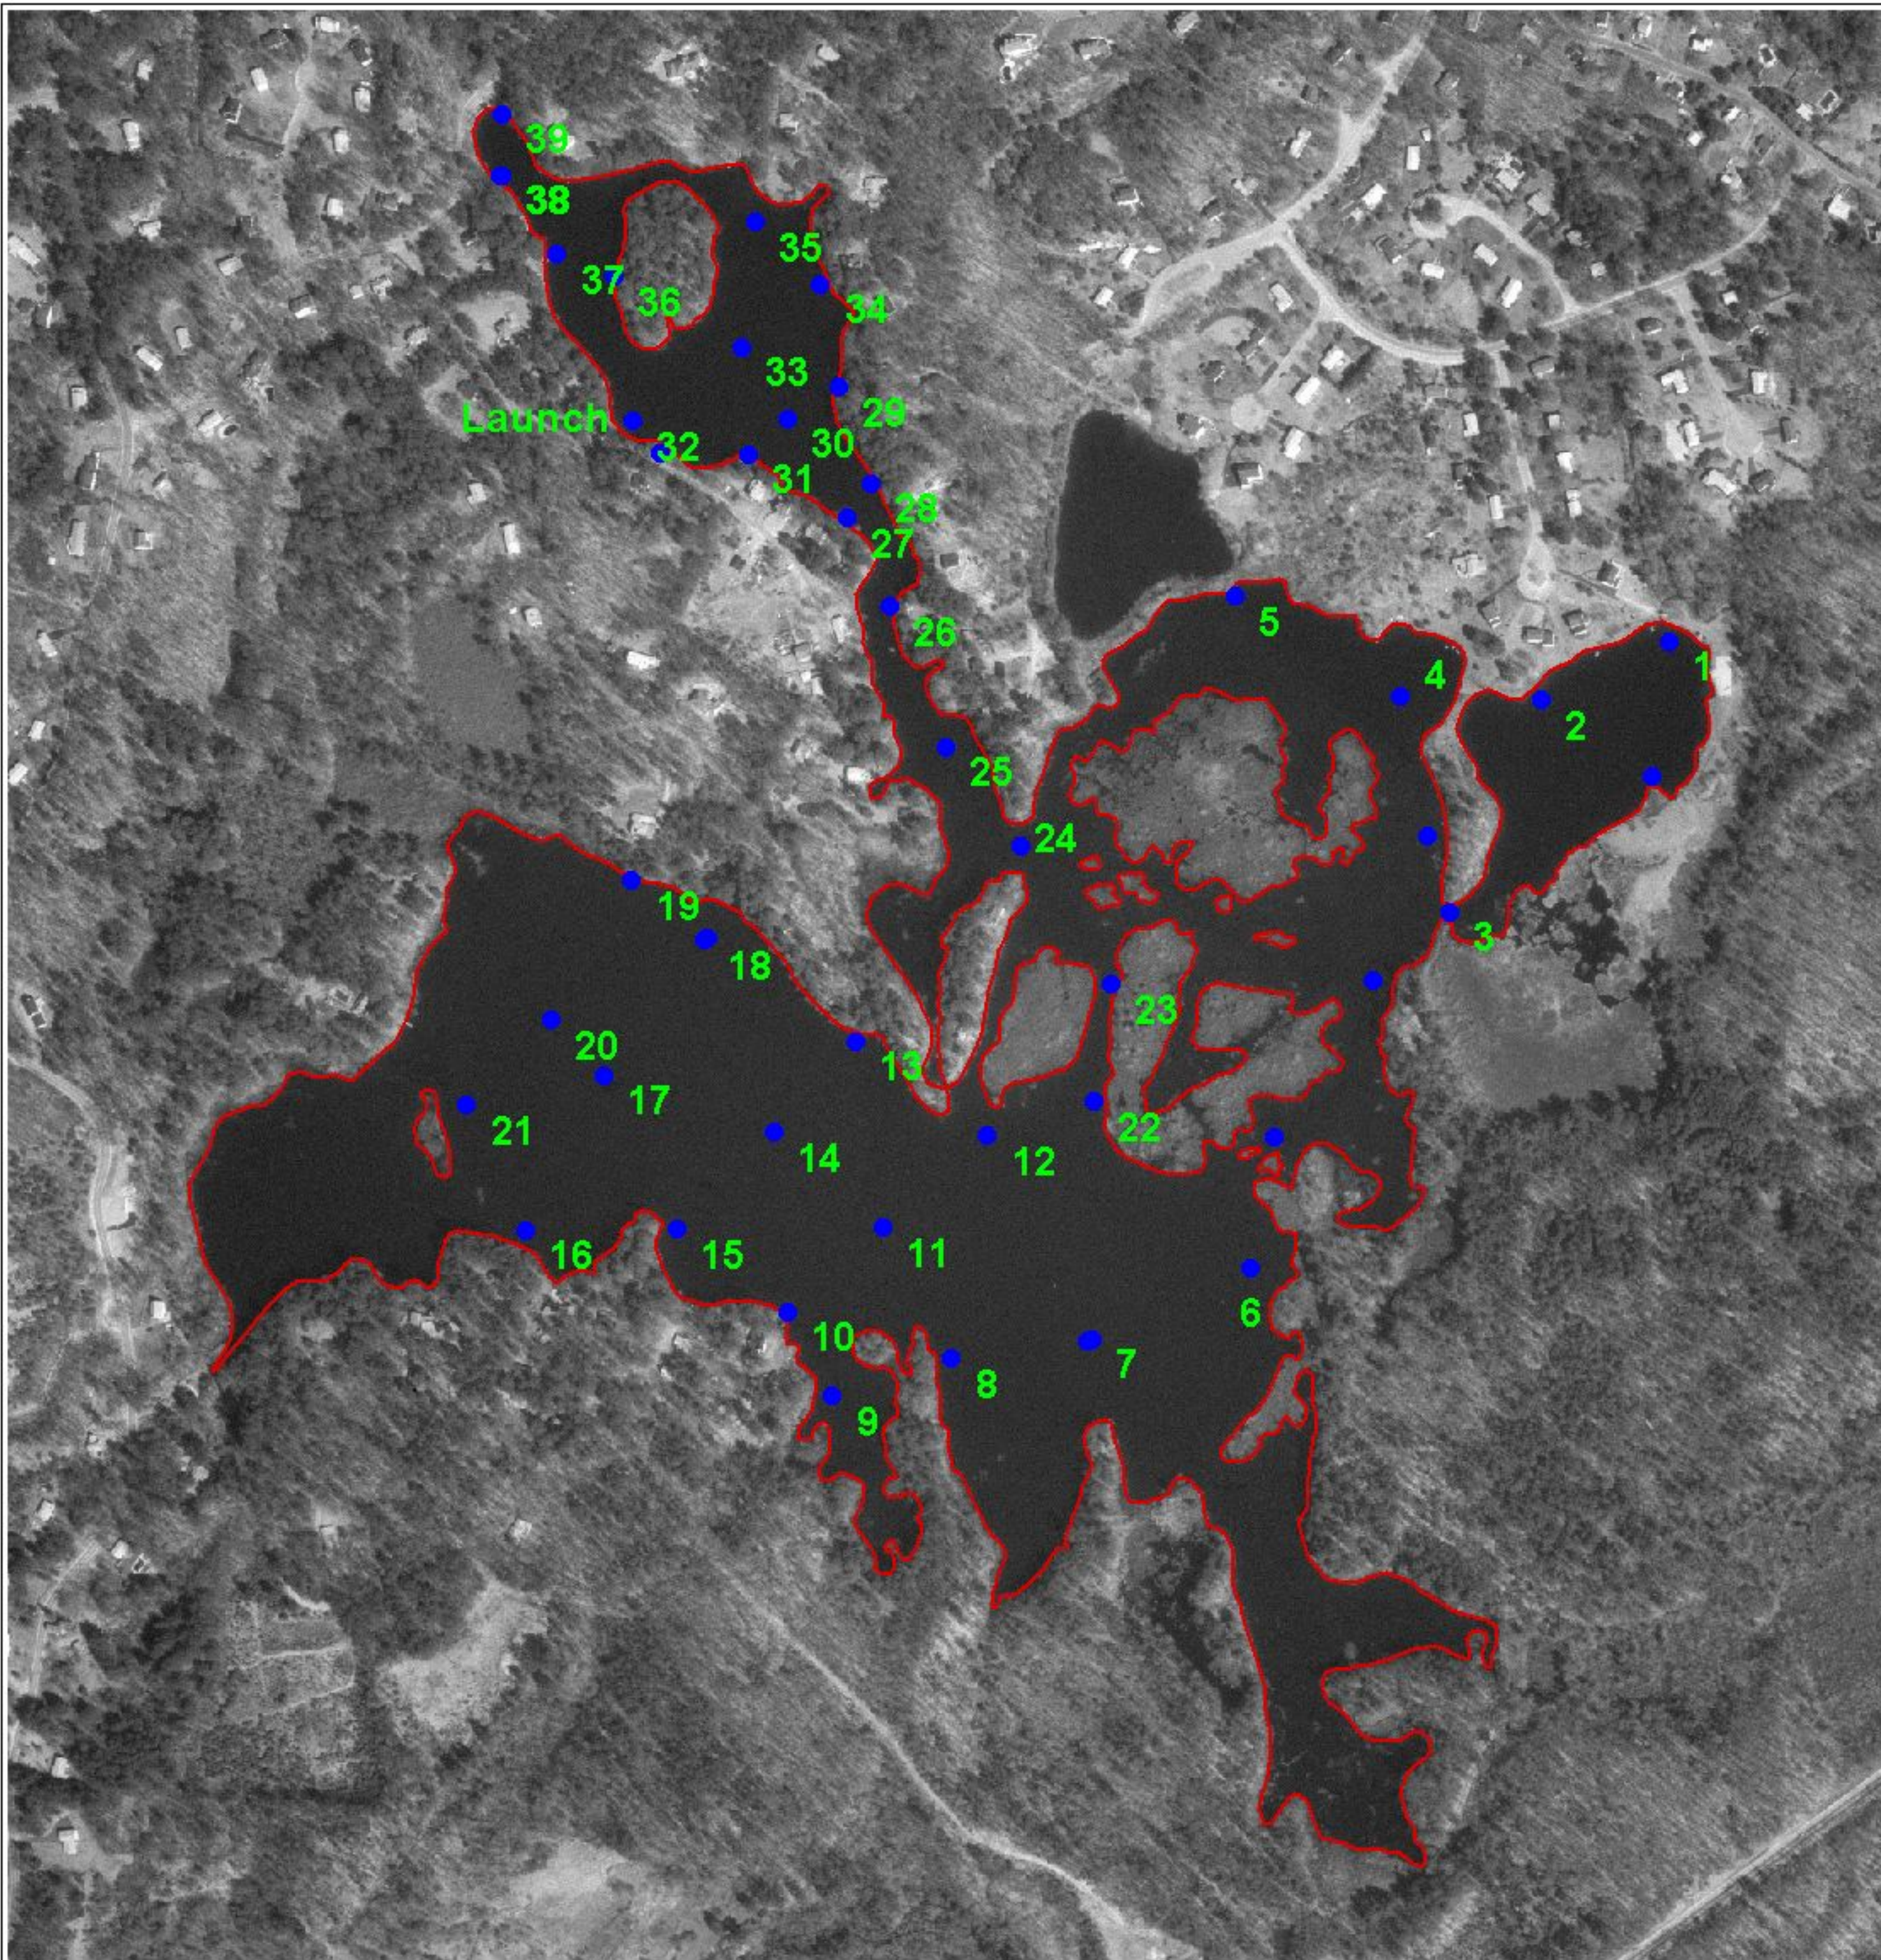
FIGURE 2

Data Point Survey Locations

● Data Point Locations - geospatially referenced using DGPS

On September 14, 2005 Marc Bellaud replicated the pre-treatment survey by visiting pre-established data points which were located with the use of Aquatic Control's Differential GPS system (see Figure 2).

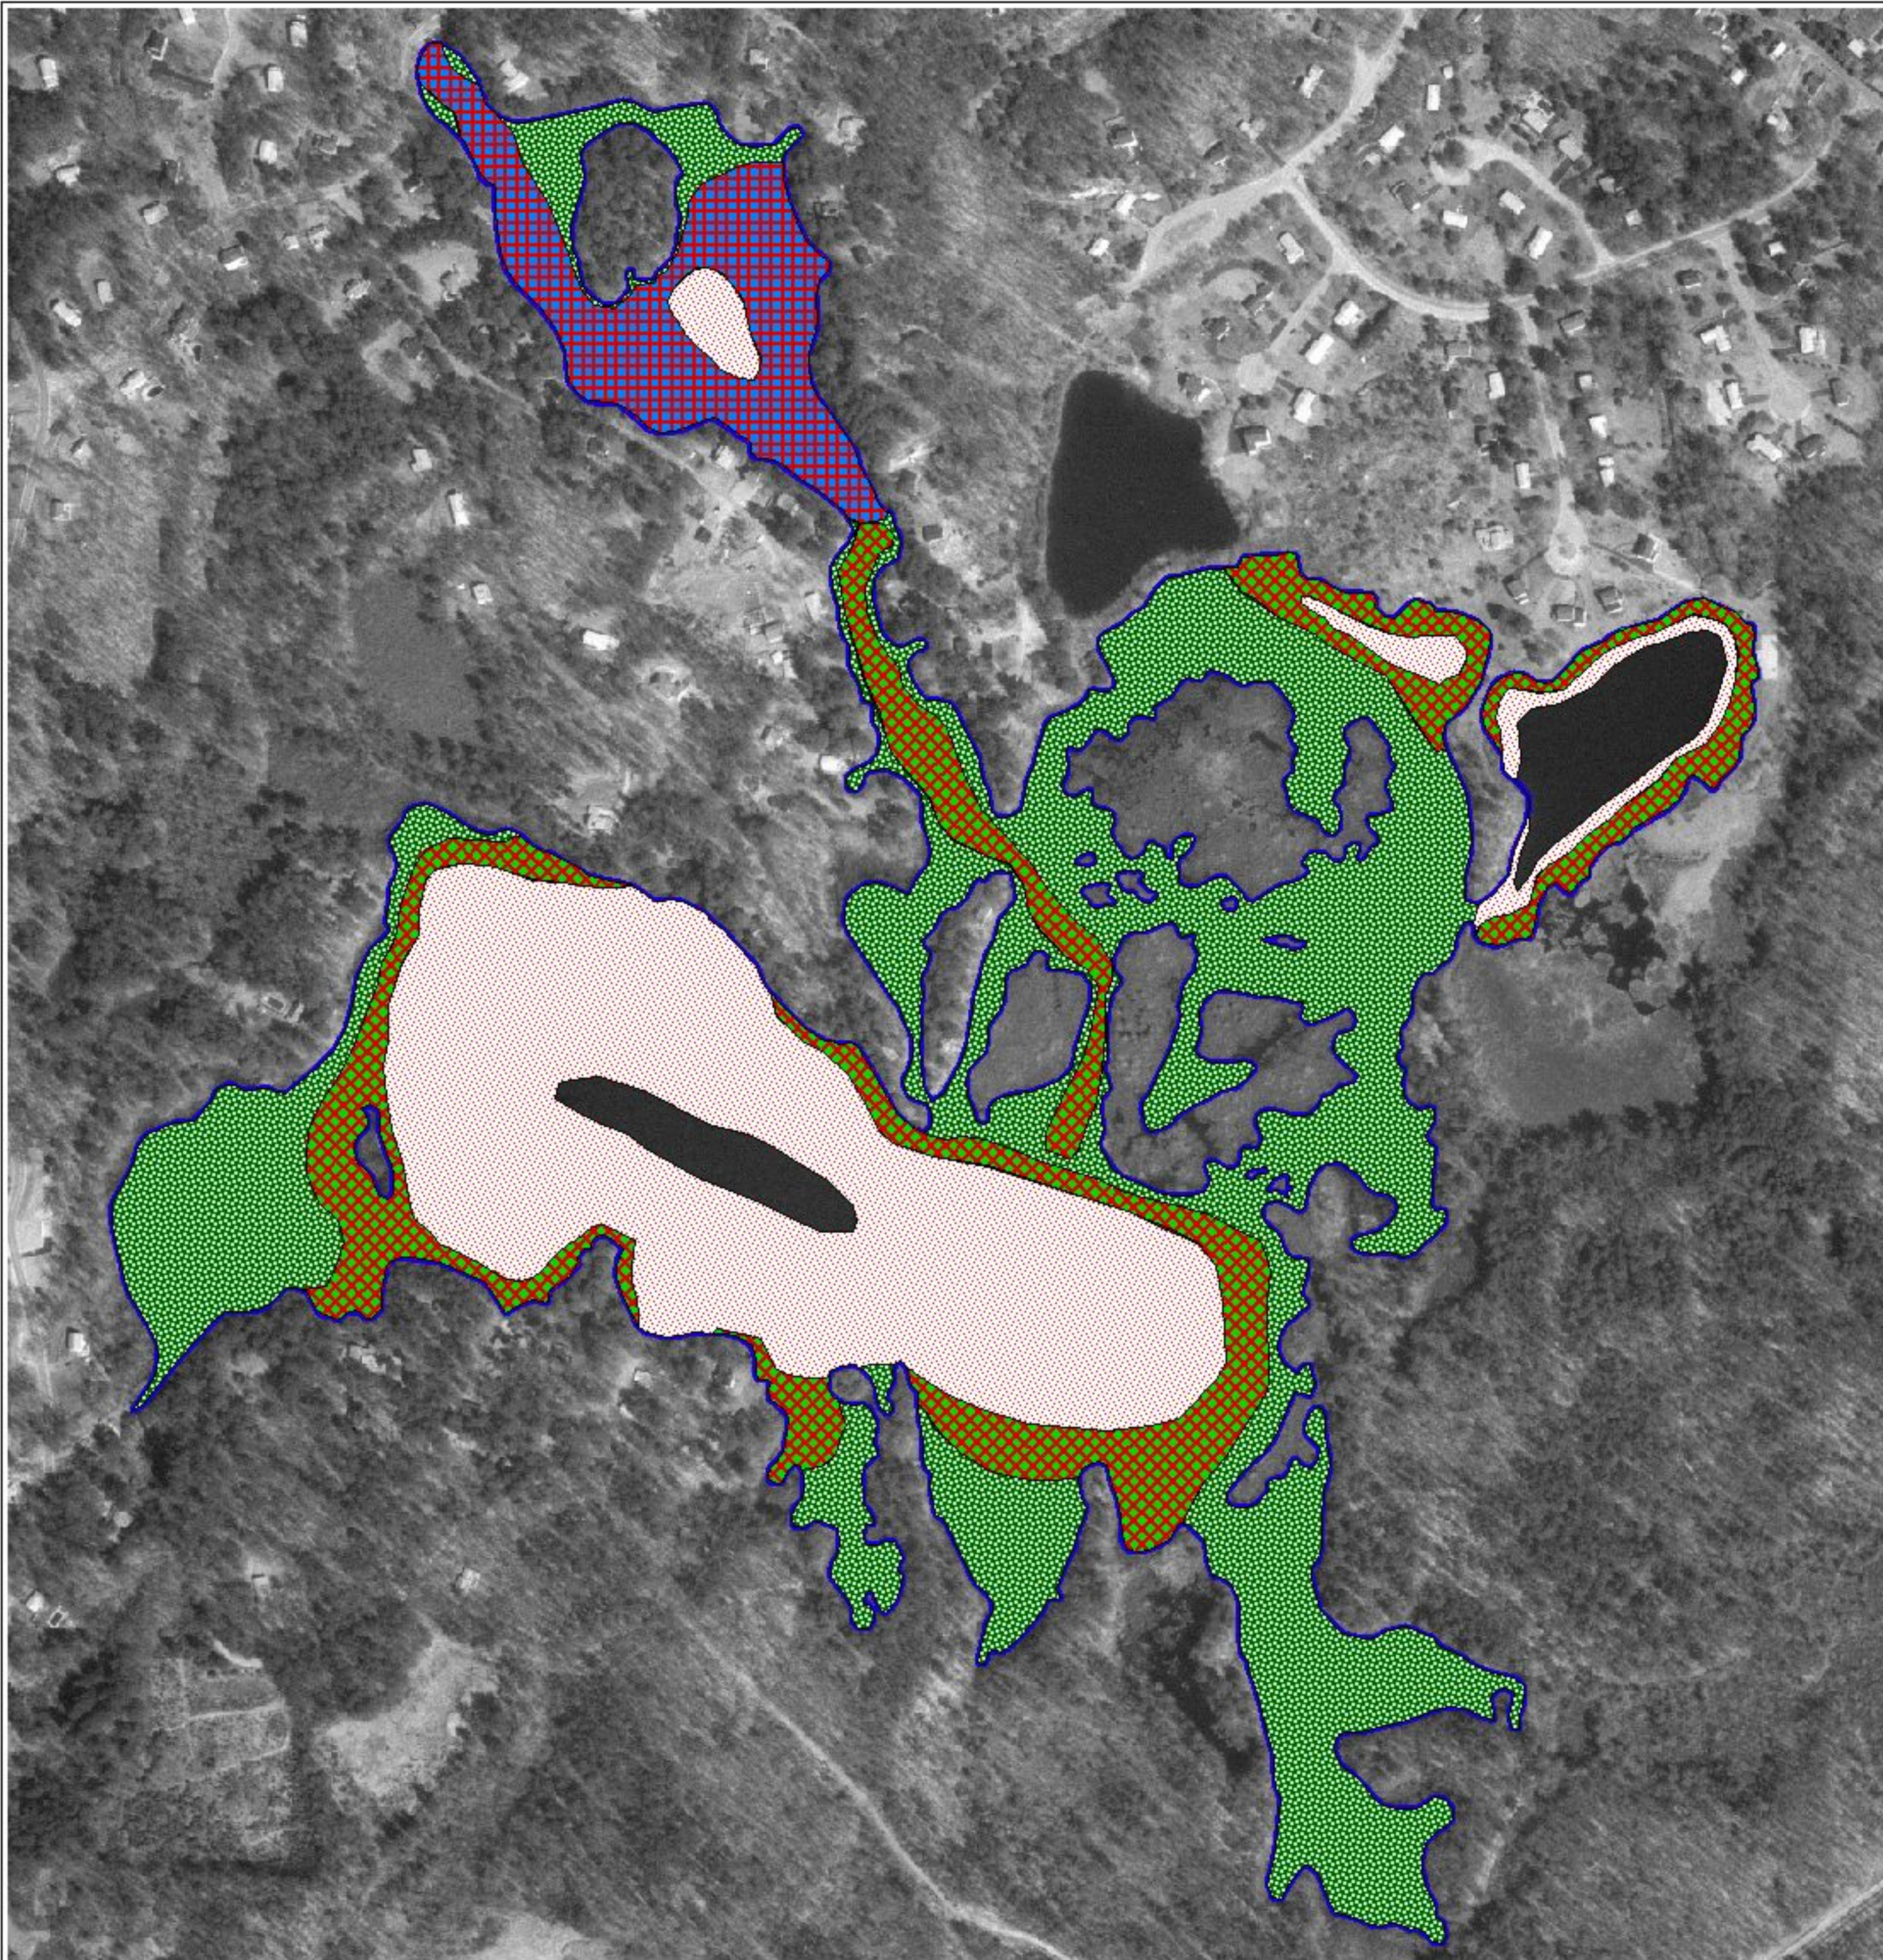
FIGURE 3
Dominant Vegetation
Assemblages (2004)

-   Common to abundant fanwort
lesser amounts of bladderwort
and coontail
-   Common to abundant fanwort lesser
amounts of pondweeds, bladderwort
and water marigold
-   Common to abundant fanwort and
waterlilies lesser amounts of
bladderwort and coontail
-   Abundant waterlilies
-   No significant vegetation cover

Pre and post-treatment monitoring of the aquatic plant community was an integral component of this management program. The comprehensive aquatic plant survey performed on August 14, 2004 provided the most accurate pre-treatment assessment of the plant community at its peak biomass. The pond was also inspected prior to the initial treatment on June 6th to document early season plant conditions. On May 16th the fanwort was actively growing and in most areas already exceeded 25% coverage. The fanwort distribution was consistent with what was reported in the 2004 survey (Figure 3).

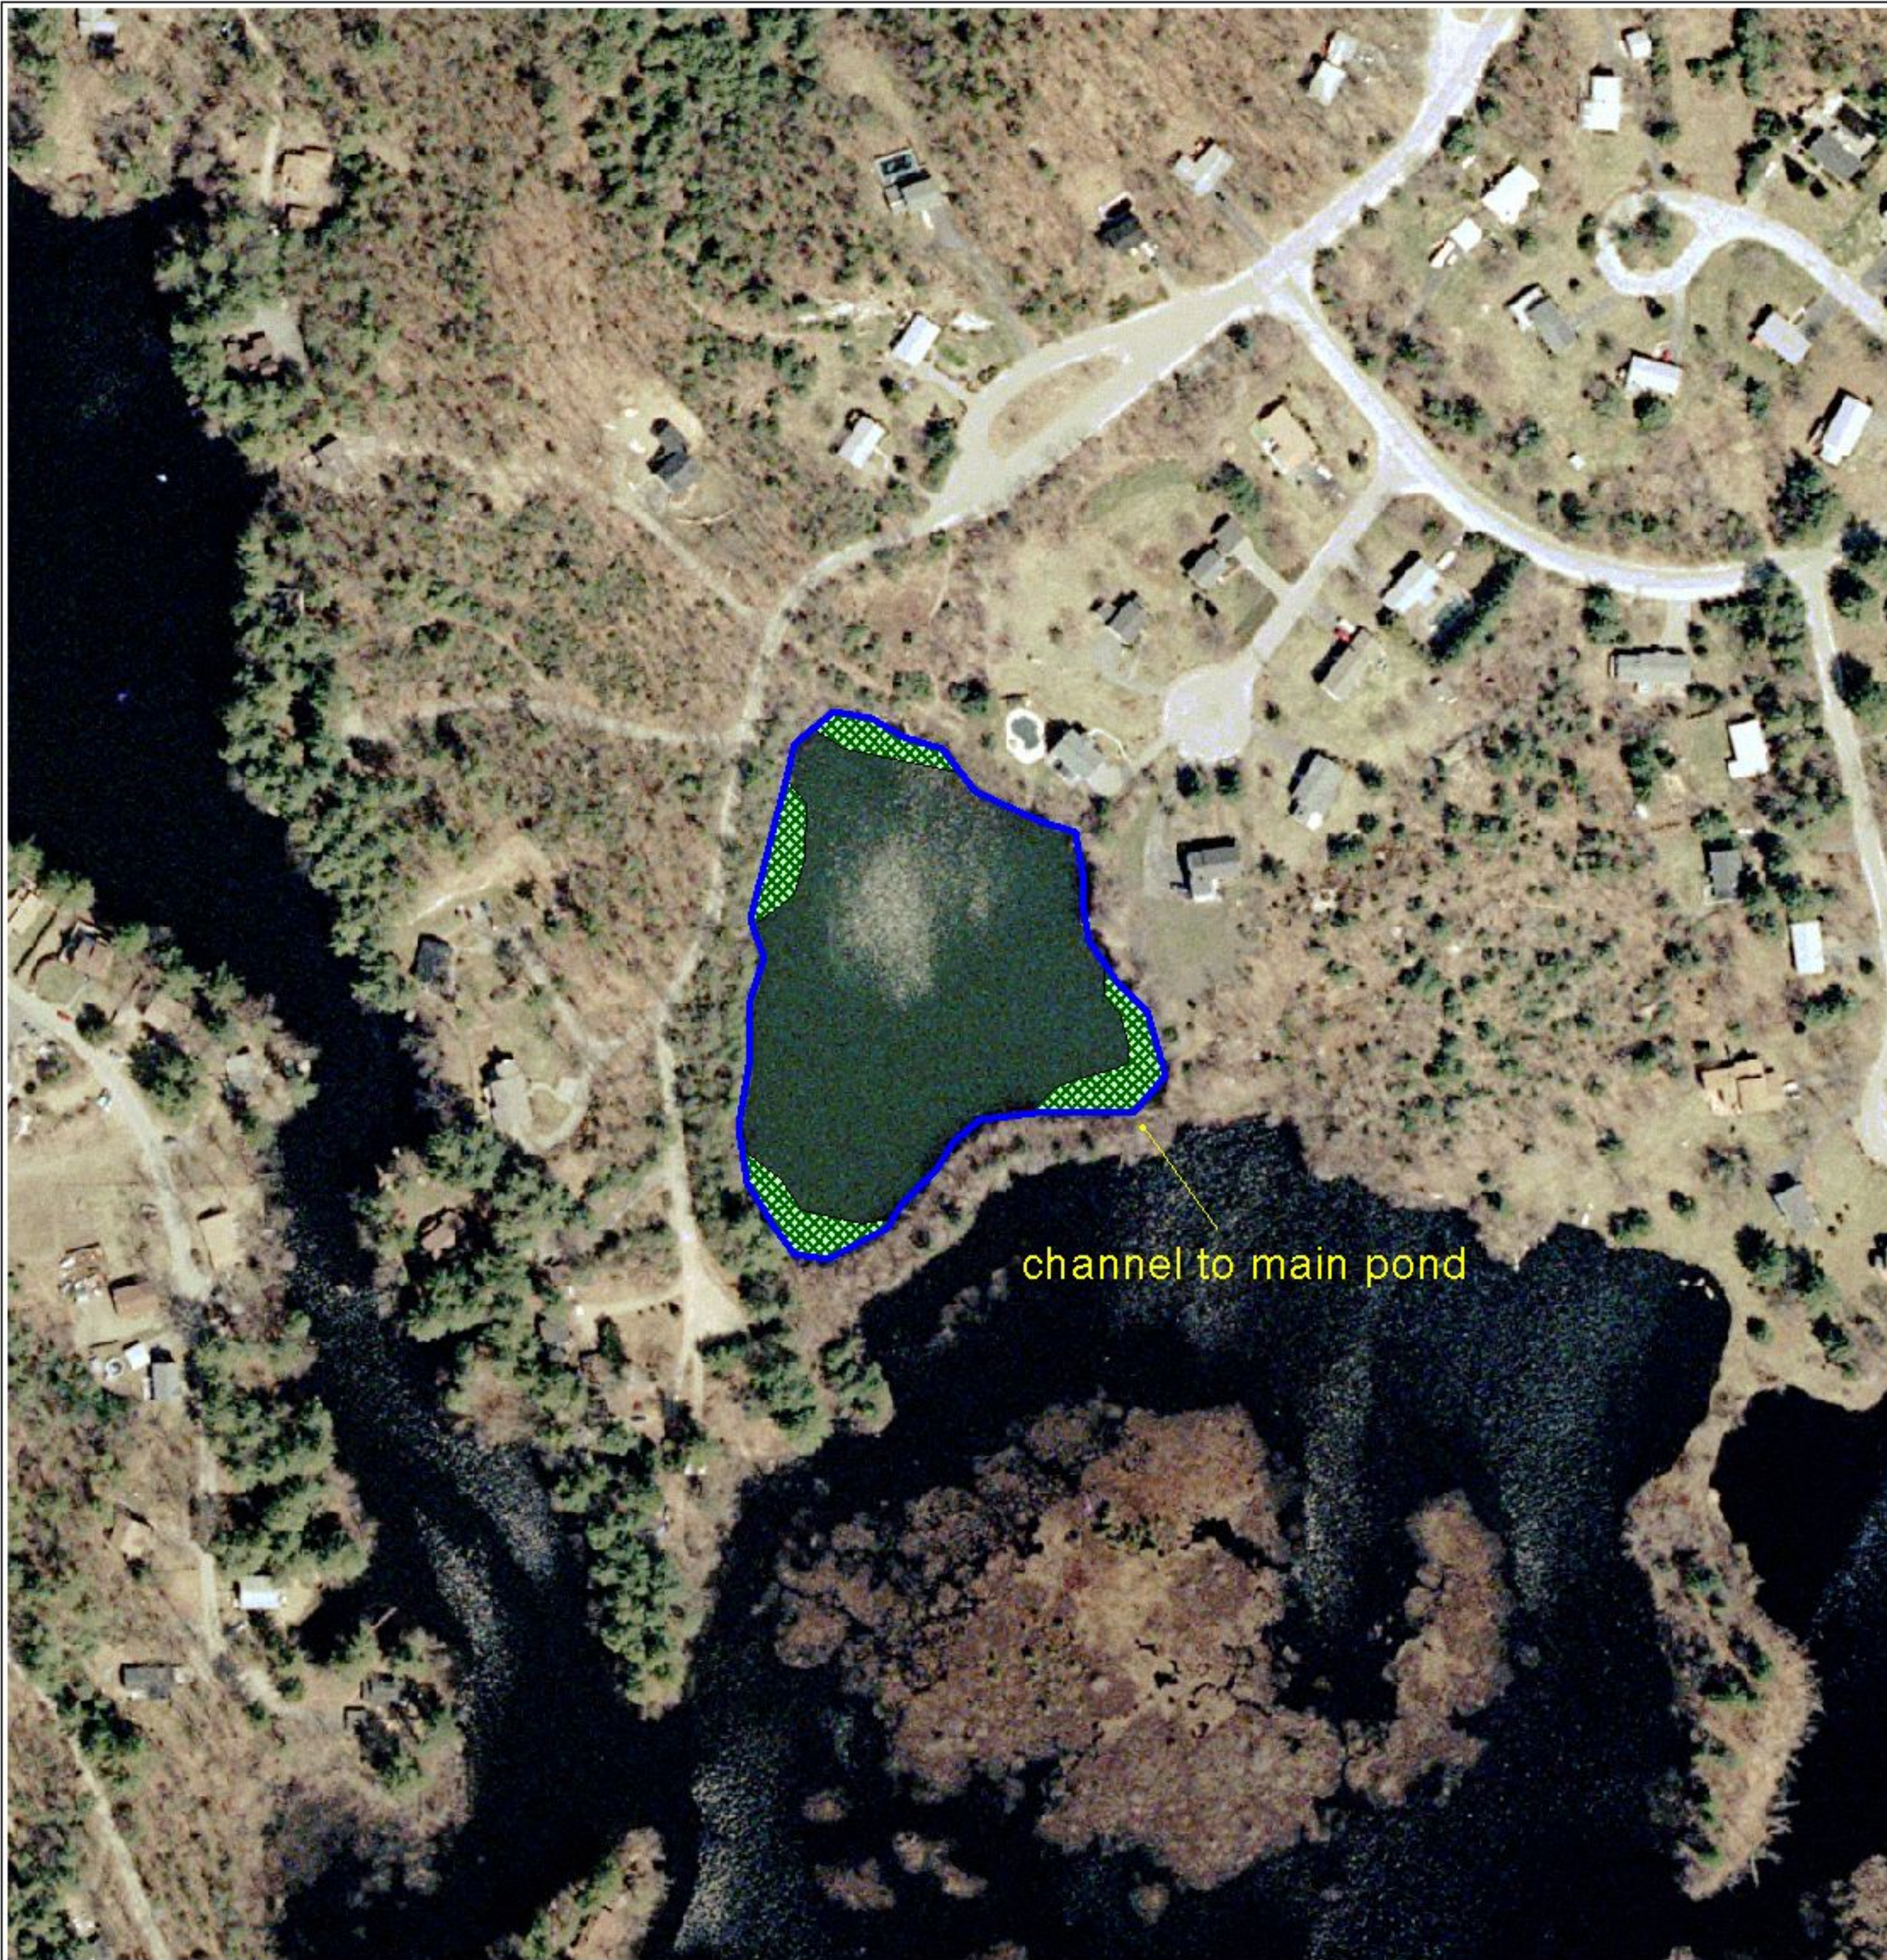
FIGURE 4
Dominant Vegetation
Assemblages (2005)

-   Dominated by coontail and filamentous algae with lesser amounts of aquatic moss and quillwort (cover >50%)
-   Dominated by White waterlilies (coverage >50%)
-   Dominated by coontail and filamentous algae with lesser amounts of bladderwort, nitella & quillwort (cover 10-50%)
-   No vegetation
-   Floating Islands

A final comprehensive data point survey was conducted by Marc Bellaud, Senior Biologist with Aquatic Control, on September 14th. Steve Cotton of the Foster's Pond Corporation accompanied Marc on this survey. The survey revealed low density bottom coverage dominated by coontail (*Ceratophyllum*) and filamentous algae. Only one small patch of fanwort was encountered in the northern section of Mill Reservoir; the plants were described as highly chlorotic and unhealthy.

Although the number and abundance of plant species encountered at each data point on September 14th was considerably lower than what had been observed in 2004, plant coverage was maintained throughout much of the previously vegetated areas dominated by coontail. Densities and abundance of each plant varied between sites within the pond; however, the general plant assemblage was relatively homogeneous. For purposes of documentation we have distinguished between plant bed densities ranging from 0-50% and 50-100% to create baseline patterns from which the future health of the native plant beds in Foster’s Pond can be judged (see Figure 4). Occurrences of other submerged aquatic plants were too scattered and patchy to account for variations within the waterbody’s plant assemblages. There were no observed impacts to truly emergent species located on the adjacent wetlands and along shore. Floating-leaved waterlilies were considerably thinned-out and decaying waterlily rhizomes were noticed in many of the wetland areas, particularly in the Mill Reservoir area and the east and west coves off the Main Pond.

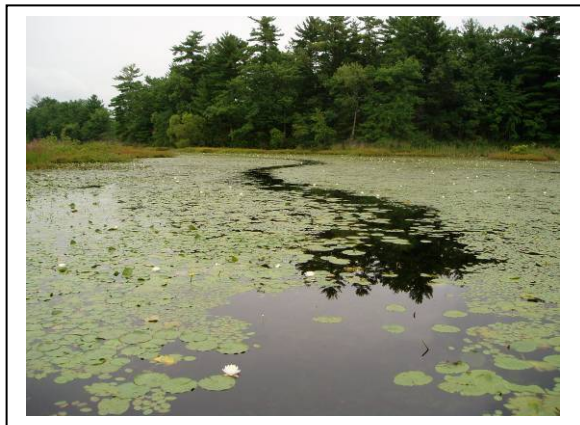
BEFORE – channel leading to Mill Reservoir
8/16/04

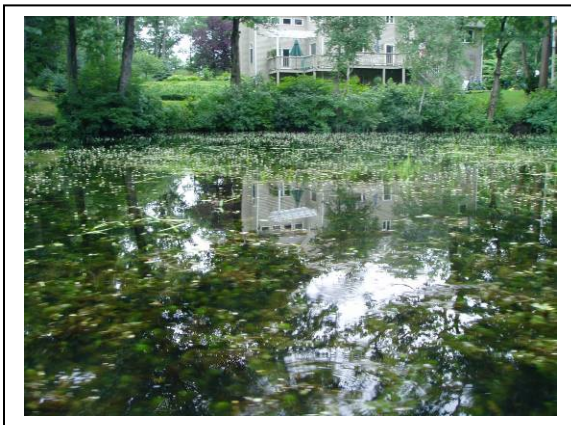
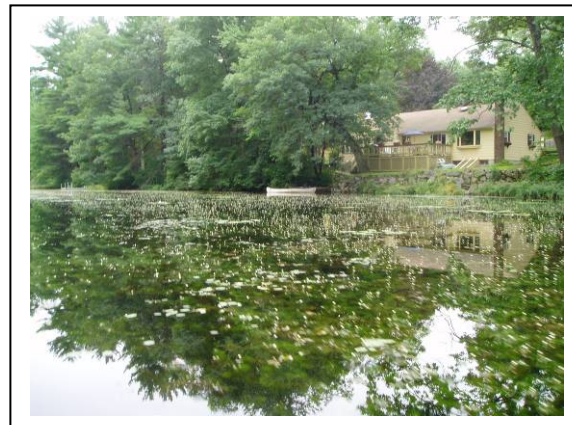
BEFORE – Channel 8/16/04

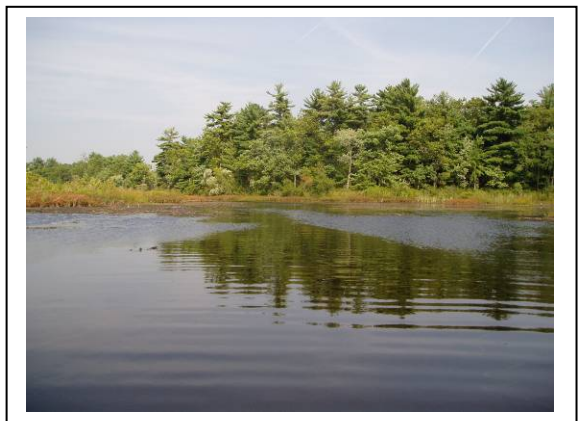
AFTER – channel leading to Mill Reservoir
9/14/05

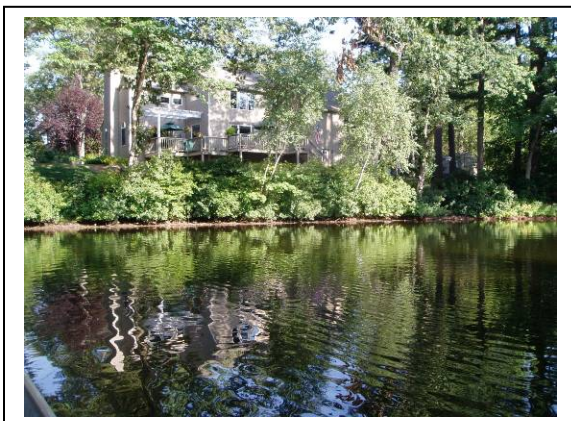
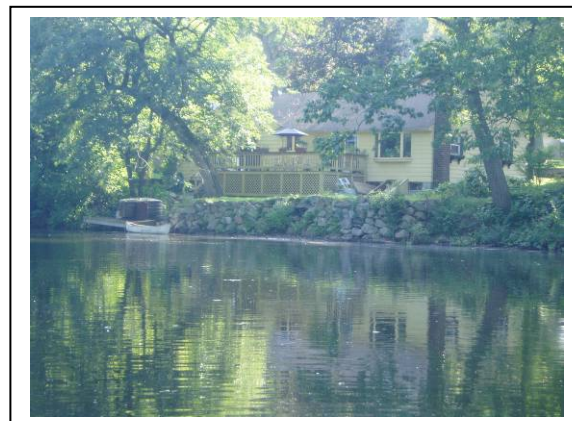
AFTER – Channel 9/14/05

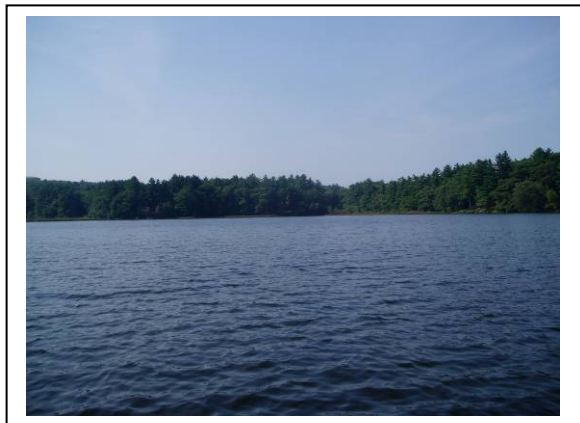
9/14/05 – Main Pond

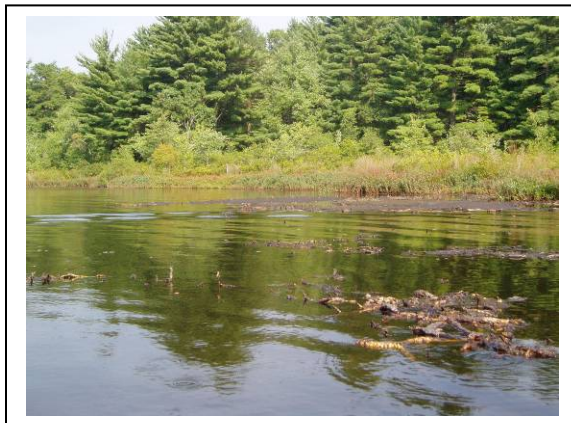
9/14/05 – adjacent wetland in Mill Reservoir

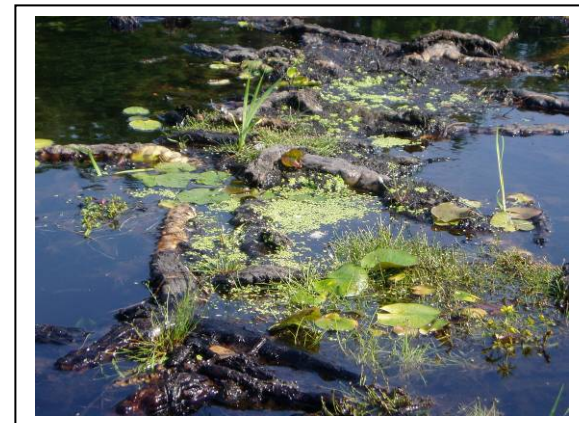
9/14/05 – floating island in eastern cove of Main Pond supporting several different plant species

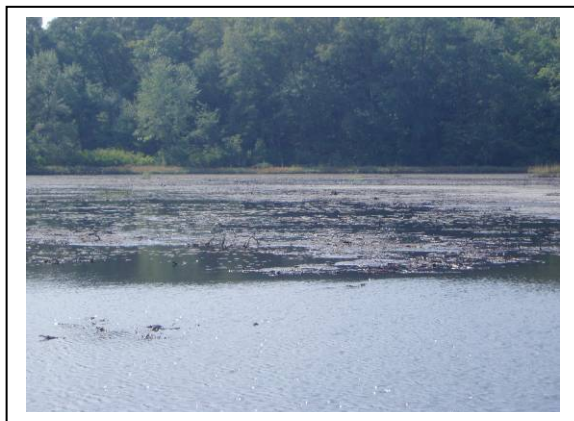
9/14/05 – southwest cove of Main Pond

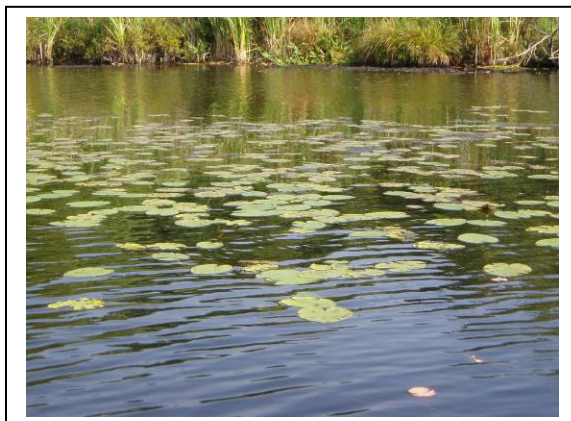
9/14/05 – thinned-out waterlily growth seen in Mill Reservoir

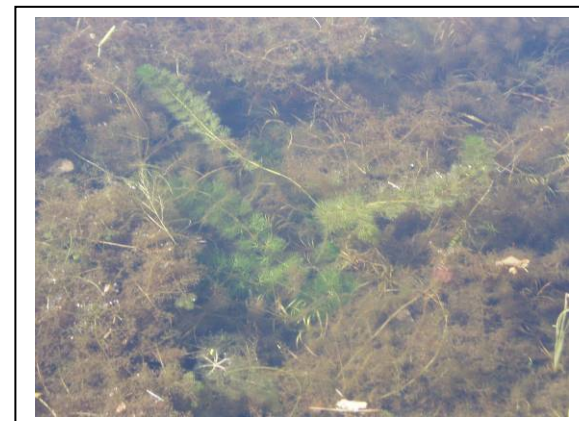
Unfortunately, there were a few established patches of fanwort found along 15-20 percent of the shoreline. There was also a small patch of a second non-native plant called Brazilian elodea (*Egeria densa*) on the southern shoreline. Both fanwort and Brazilian elodea propagate vegetatively and fragments could reinfest the remainder of Foster's Pond. Ideally this basin should be spot-treated with Sonar in 2006. The estimated program cost would be \$5500-\$6000. If treatment is not performed, then FPC members should regularly inspect the area and remove floating plant fragments and if possible initiate a hand-pulling effort.

9/14/05 – sparse fanwort growth seen in basin off of Glenwood Drive
